## Orwell River Fish Kills July 12, 1999 and July 29, 1999

### INTRODUCTION

Two fish kills were reported in the Orwell River near Kinross in July, 1999. The investigations into the two fish kills are discussed in this report.

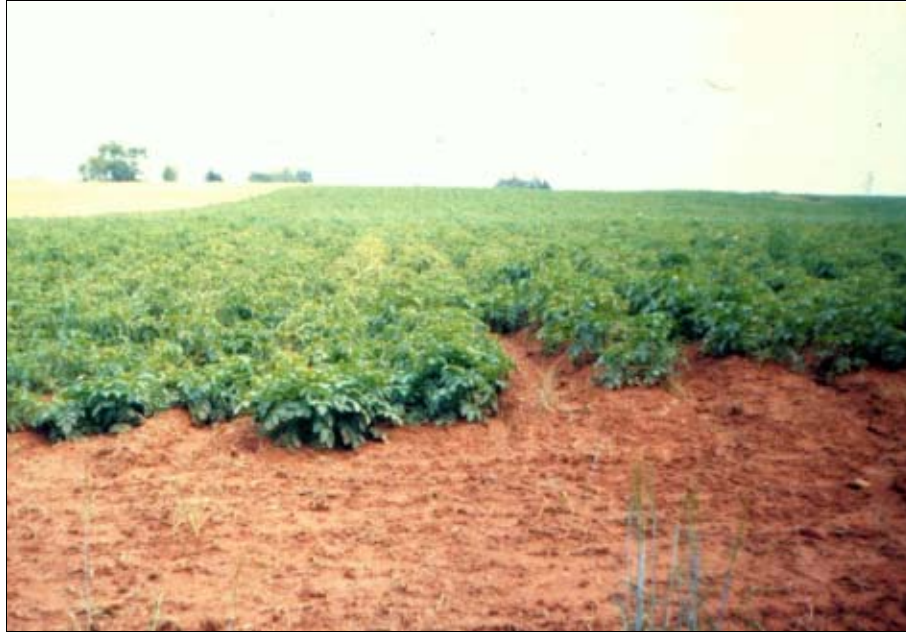
Figure 1. Suspected potato field near sampling sites PW3 and PW4 (see map in report). The photo shows the length of the rows and slope in the suspected field.

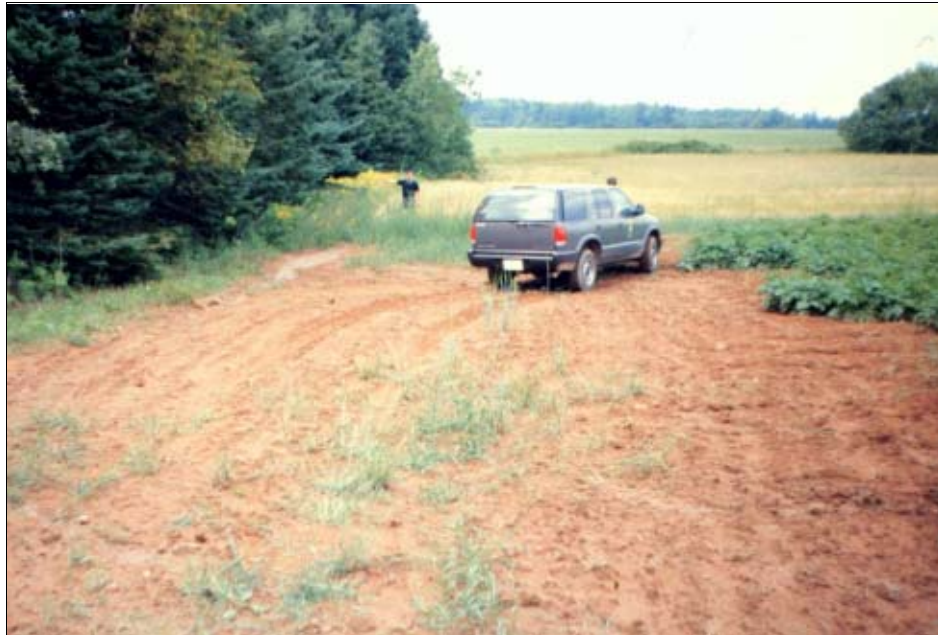
Figure 2. Staff person indicating the point where runoff from the suspected field enters the wooded buffer area between the field and stream.

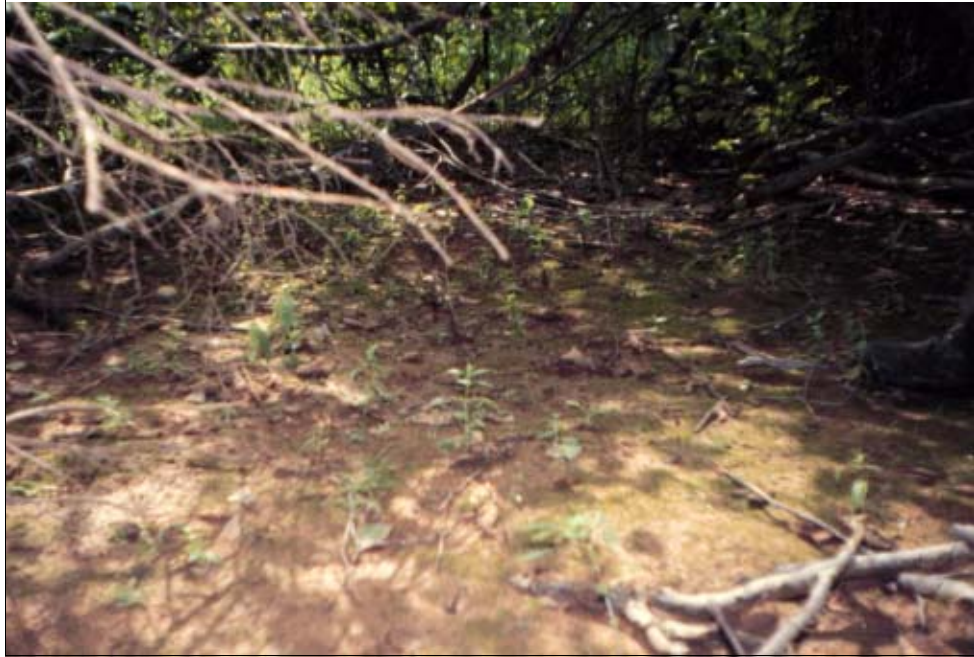
Figure 3. Photo shows the path that the runoff water from the suspected field would follow as it moved through the wooded buffer area between the suspected field and stream.

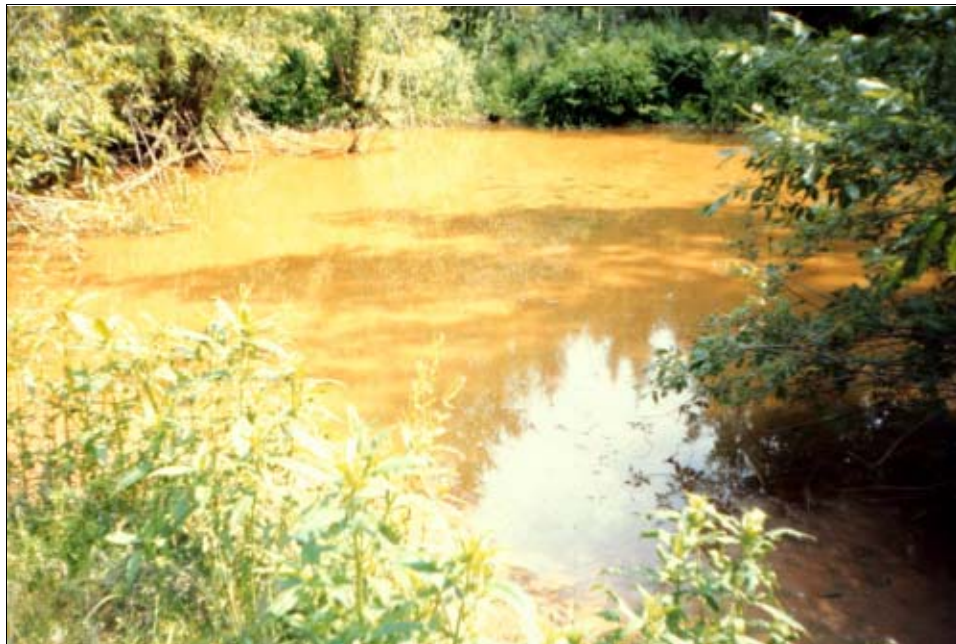
Figure 4. Depressional area where runoff water from the suspect field collects prior to reaching the stream.
